Session ID: GEO-6307
Mapping and Monitoring
for Suncor's Oil Sands Tailings
Reduction Operation process
using GPS surveying and
PhotoSat satellite topography.

Paul Lomond, Suncor Energy Inc.

Jim Turner, PhotoSat

Stereo satellite photos used to map Suncor Tailings

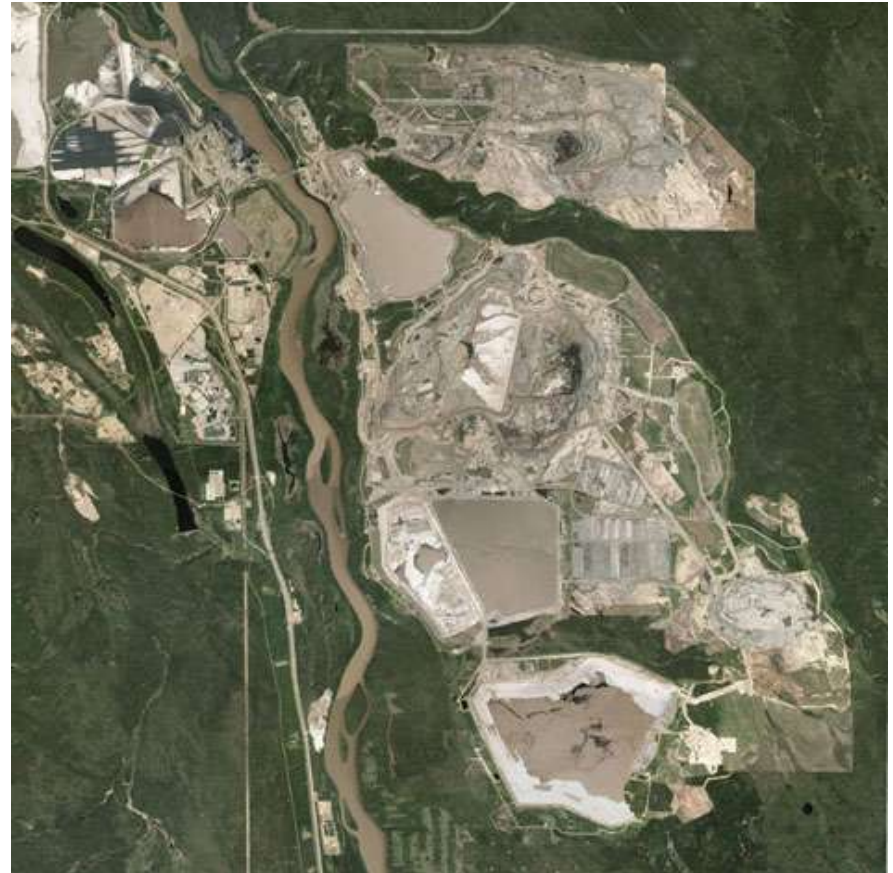
How large is the Suncor Oilsands Operation?

- **Total Mapping Area**
 - About 271 km² (66,974 acres)
- **Mining**
 - Total - Over 1,000,000 t/day
 - Oilsand - Over 400,000 t/day
- **Extraction**
 - Bitumen – Over 275,000 bbls/day
- **Tailings Ponds**
 - About 31.5 km² (7,783 acres)

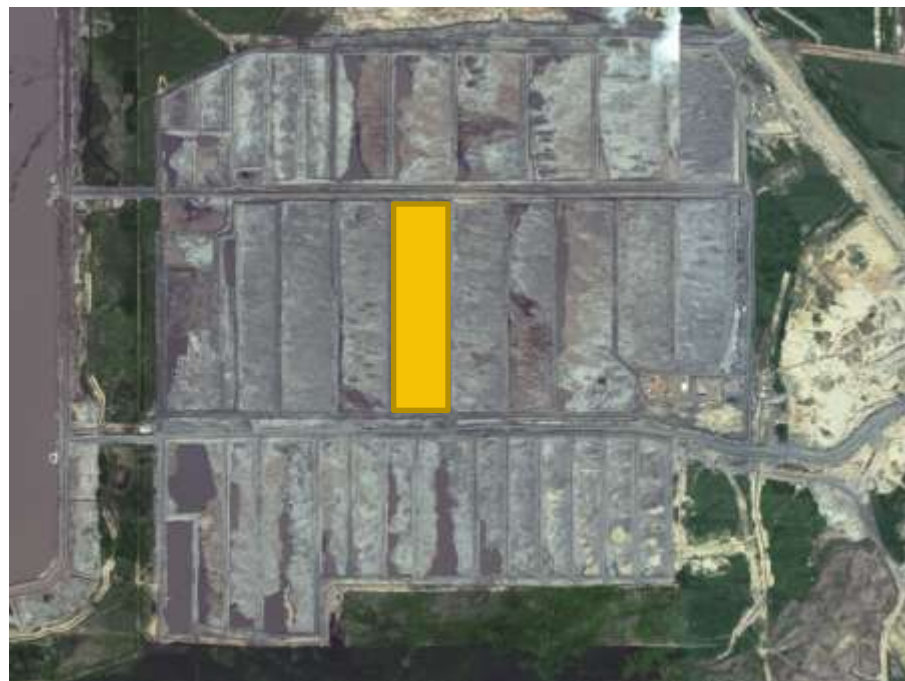
How Large is the Suncor TRO Operation?

- **Designated Drying Areas (DDA)**
- Total Surface Area 7,550,000 m² (1,866 acres)
- Tailings Sand Deposit 10,872,000 m³ /year
- 697 Tailings Cells
- 2788 Discharge Locations

- **System 7 – Field D**
 - 216m x 902m
 - 14 Cells (216m x 64m)
- **Seasonal Operation**
 - April - October

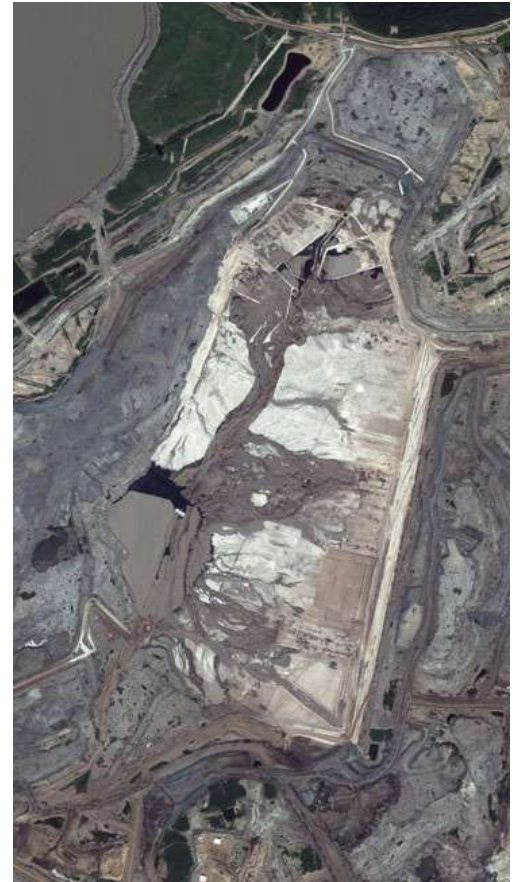
How Large is the Suncor TRO Operation?

- **Sand Dump 8 (SD8)**
- **Total Surface Area 4,053,693 m² (1,002 acres)**
- **Tailings Sand Deposit 39,015,877 m³ /year**
- **74 Tailings Cells**
- **74 Discharge Locations**
- **Operates 12 months / year**

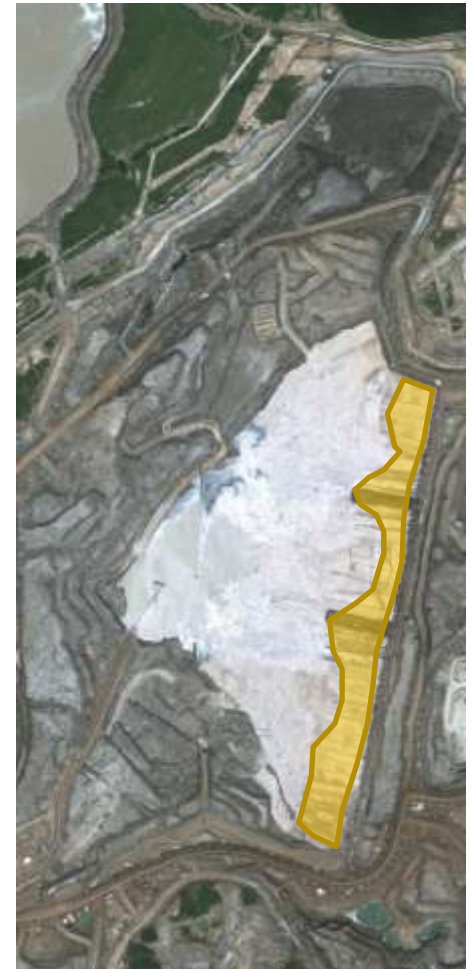
In 2012

- **Trimble GPS equipment was used on compacted areas of Sand Dump 8.**
 - **<20% of total area was accessible.**

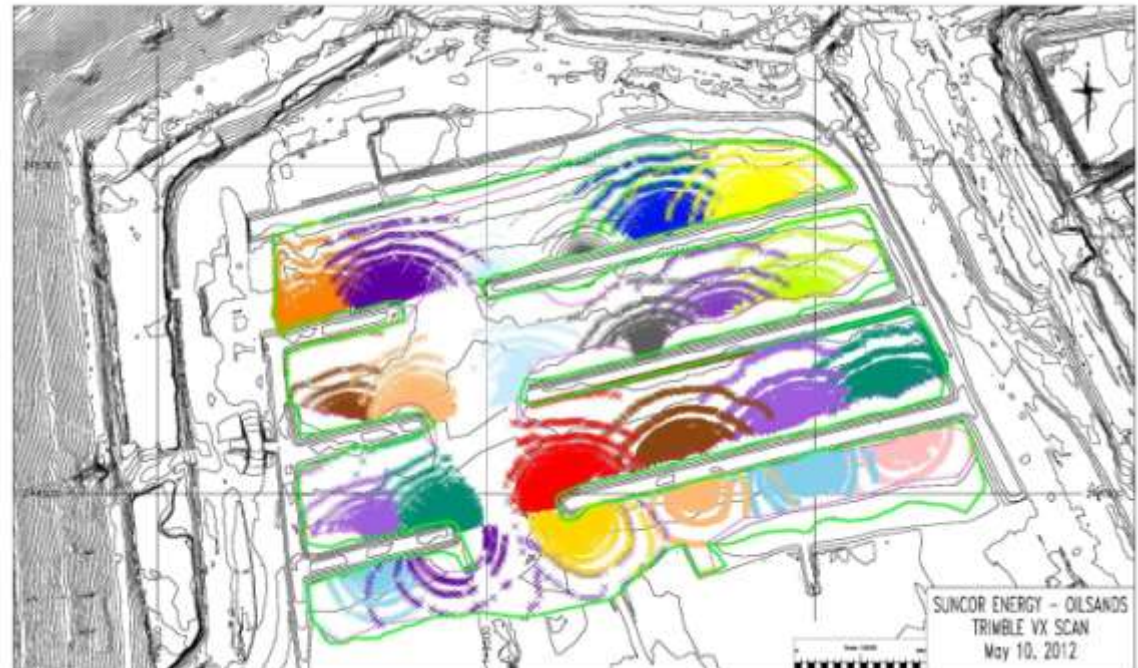
In 2012

- **Trimble VX was used to scan DDA Cells.**
 - Very slow
 - Multiple set-ups
 - Sparse data

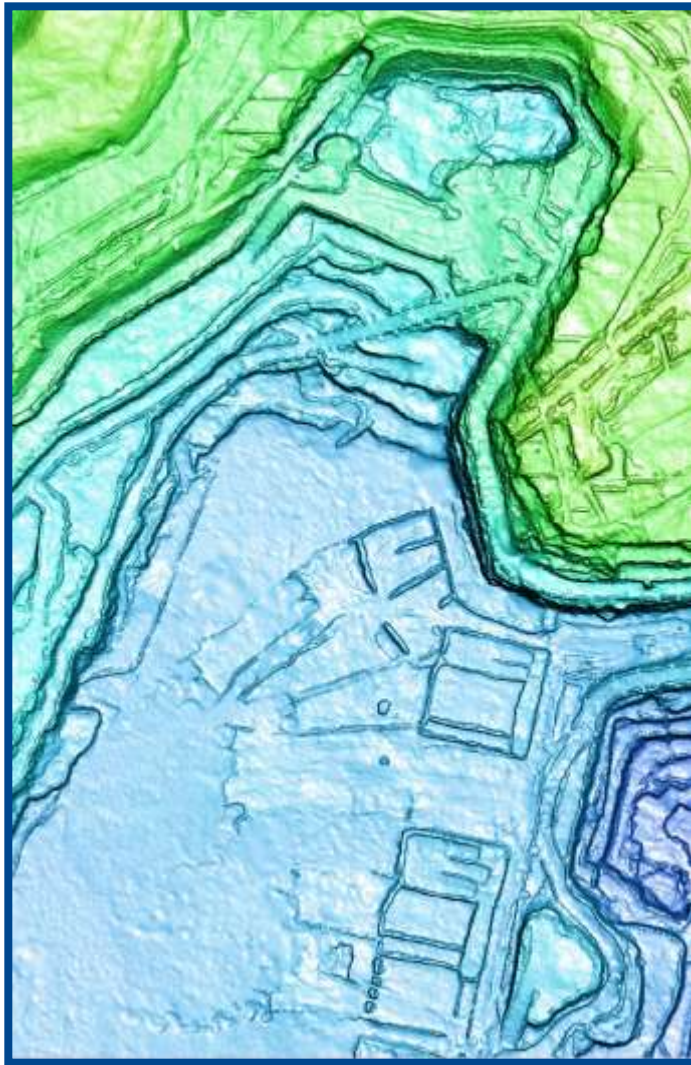
Jan 20, 2013

Many features visible in the Jan 20 satellite topography have been buried by tailings by Feb 23.

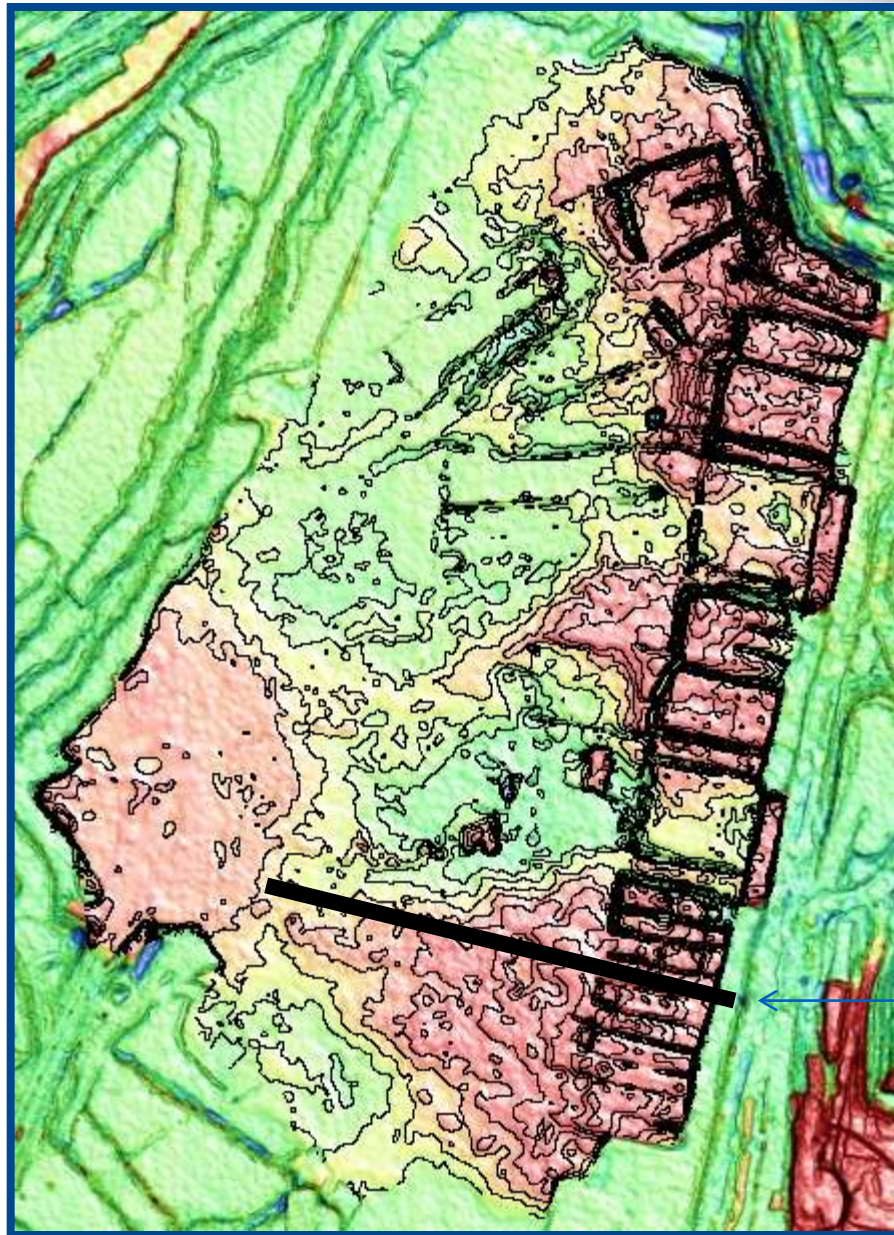
← Cross-Section

**50 cm tailings thickness contours
Jan 20 to Feb 23, 2013**

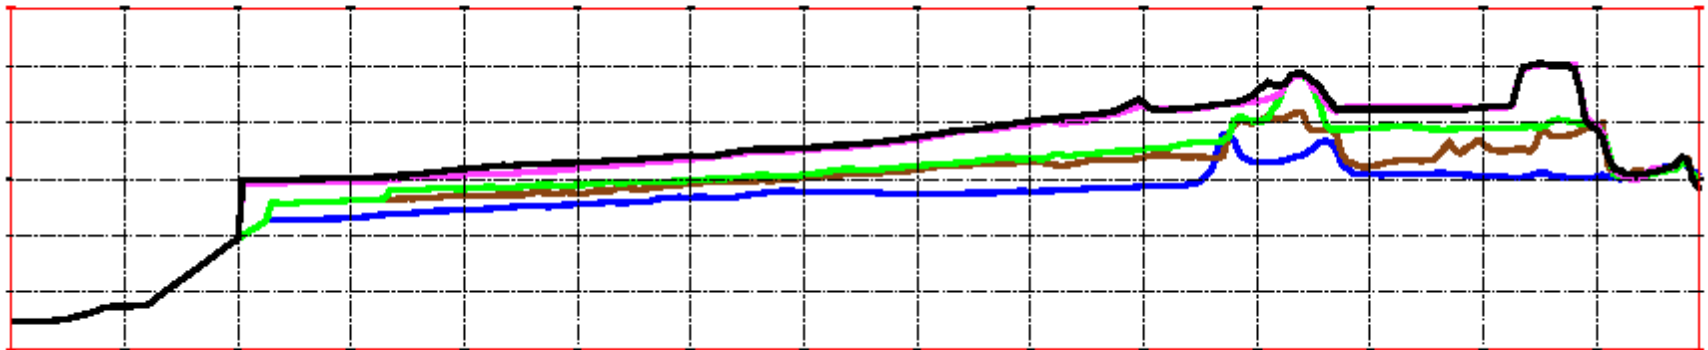
Cross-section at Sand Dump 8

- **First 5 surfaces from PhotoSat (2013)**
 - January 11 - Blue
 - February 23 - Brown
 - March 23 - Green
 - April 15 - Magenta
 - April 24 - Black

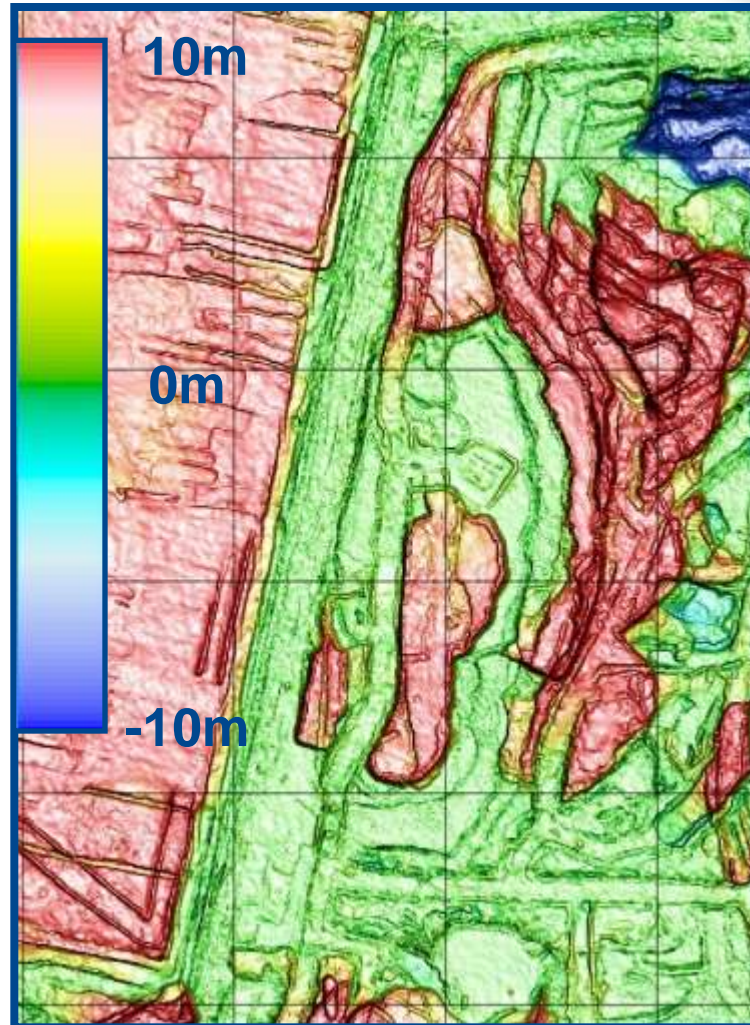
**Thickness Dec 30, 2013
to July 29, 2014**

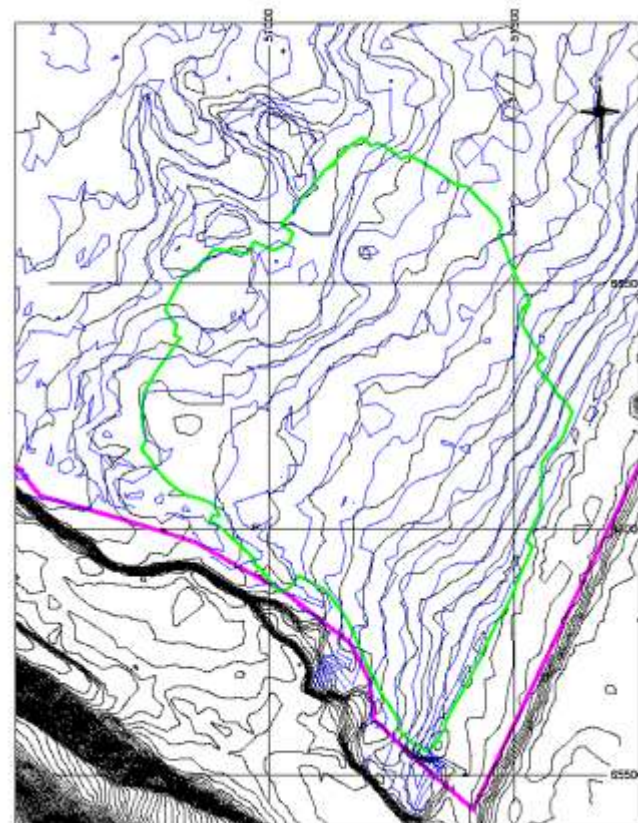
Pond 6 Beach Excavation Survey

GPS and satellite mapping match to ½ inch

■ Pre Excavation Survey

- GPS Data - Blue 1' contours
- PhotoSat Data - Black 1' contours

■ Excavation Survey

- GPS Data

- GPS surface – Excavation surface 77,982 yds³
- PhotoSat surface – Excavation surface 77,041 yds³
- Difference (1.2%) 941 yds³

- $941 \text{ yds}^3 / 70,134 \text{ yds}^2 = 0.0134 \text{ yds} = \frac{1}{2} \text{ inch}$

- On average, the PhotoSat data was lower than the GPS data by ½ inch.

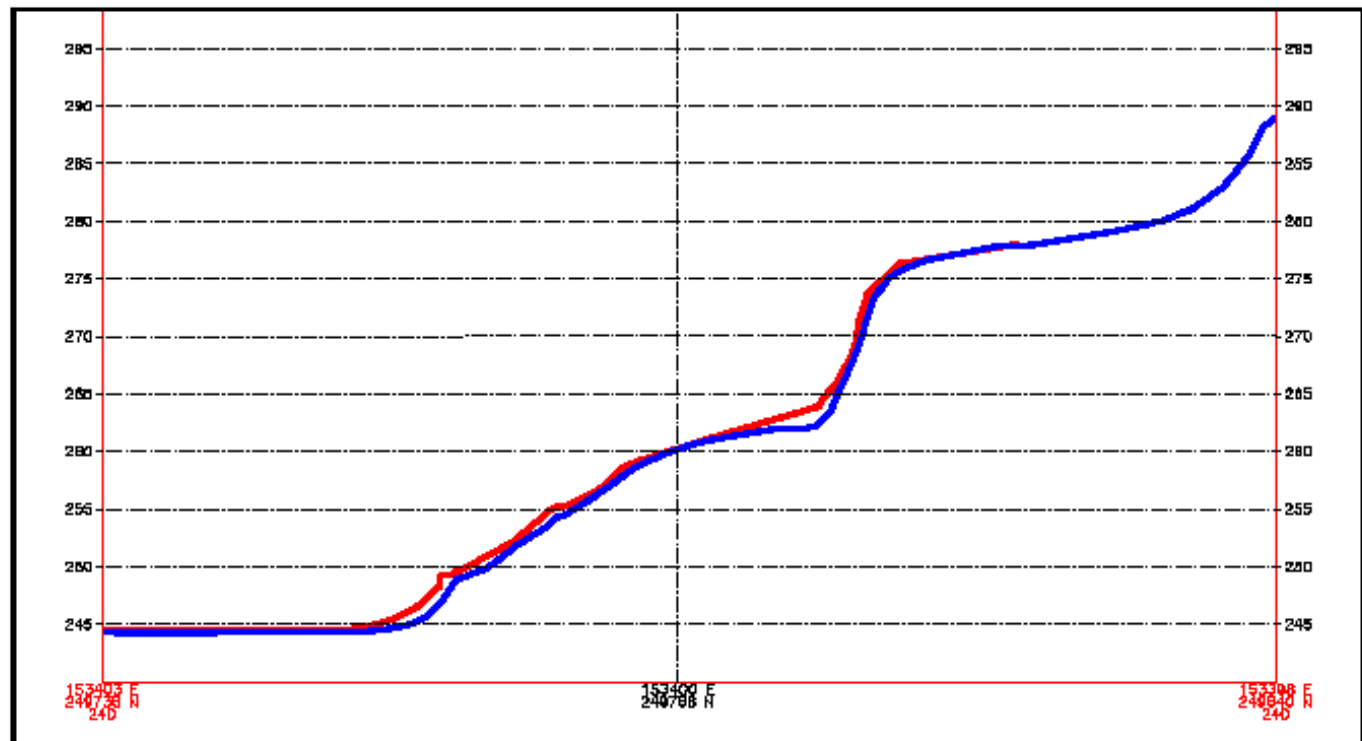
Millennium Pit – Cross Sections

- Blue Line - PhotoSat Data
- Red Line – Trimble VX Scan Data

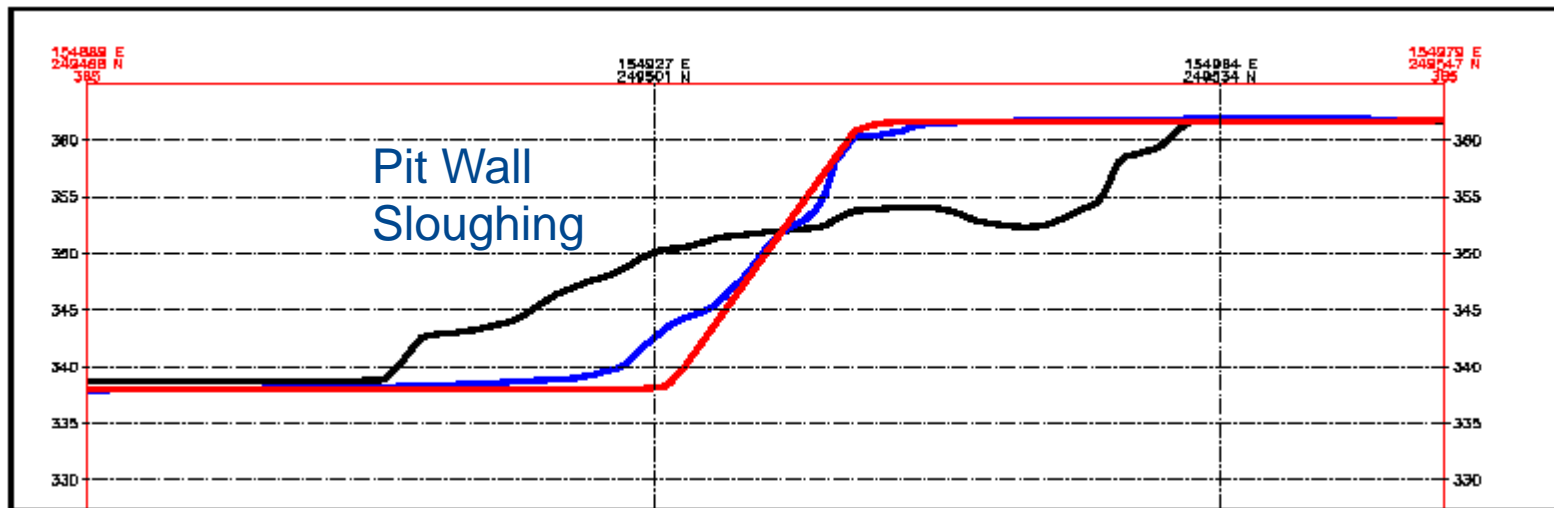
Millennium Pit – Cross Sections

- Overburden Top Cut
 - Red Line – GPS Survey Data – March 9
 - Blue Line – PhotoSat Data – March 7
 - Black Line – PhotoSat Data – April 3
 - PhotoSat captured sloughing which is unsafe to survey with GPS.

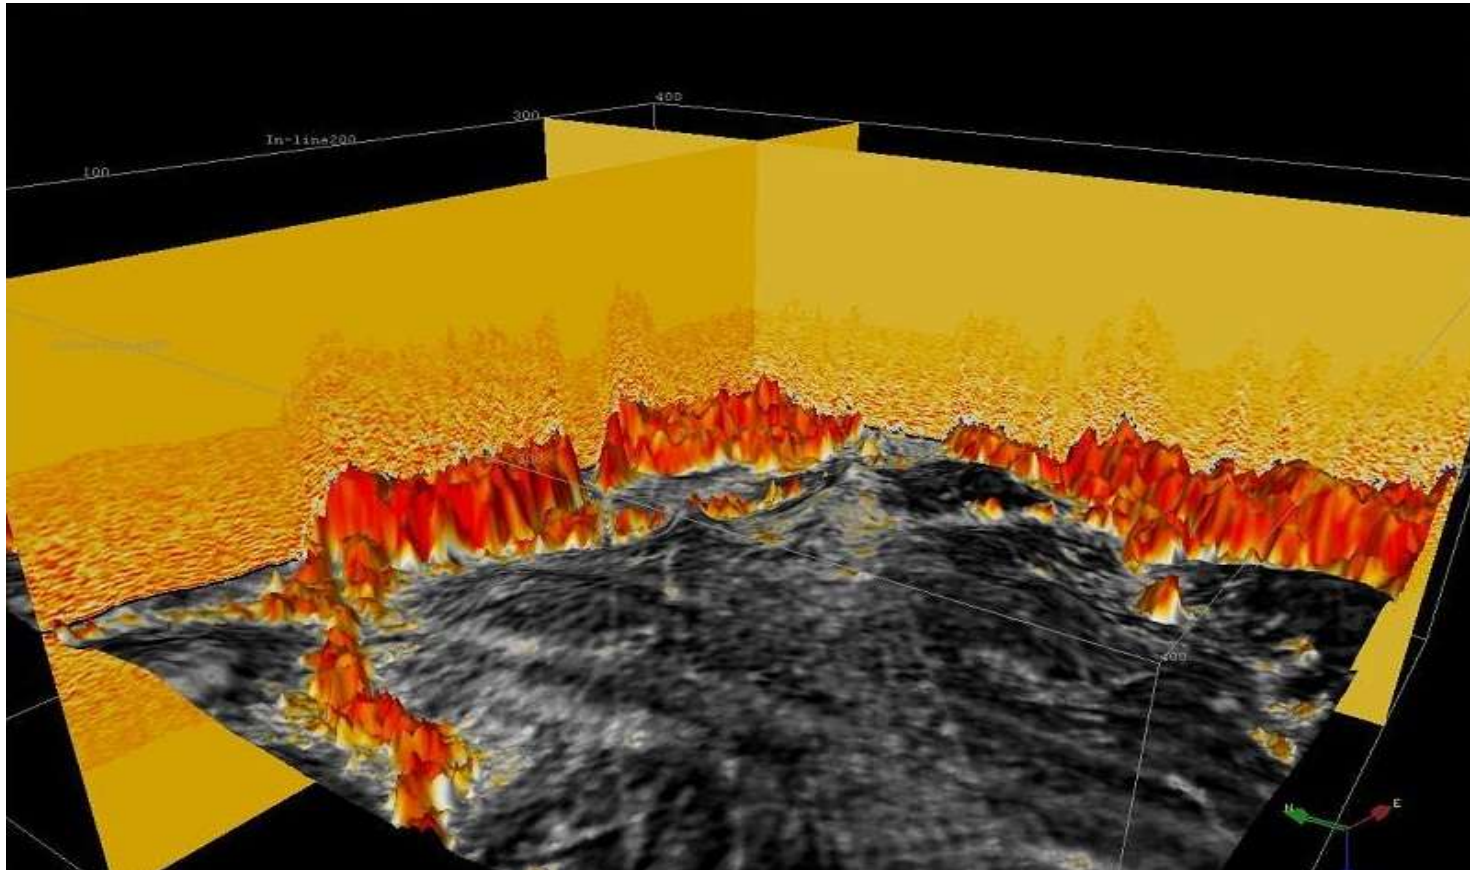
Ground elevations are measured from the parallax of the satellite stereo pairs.

“Seismic” processing of stereo satellite photos

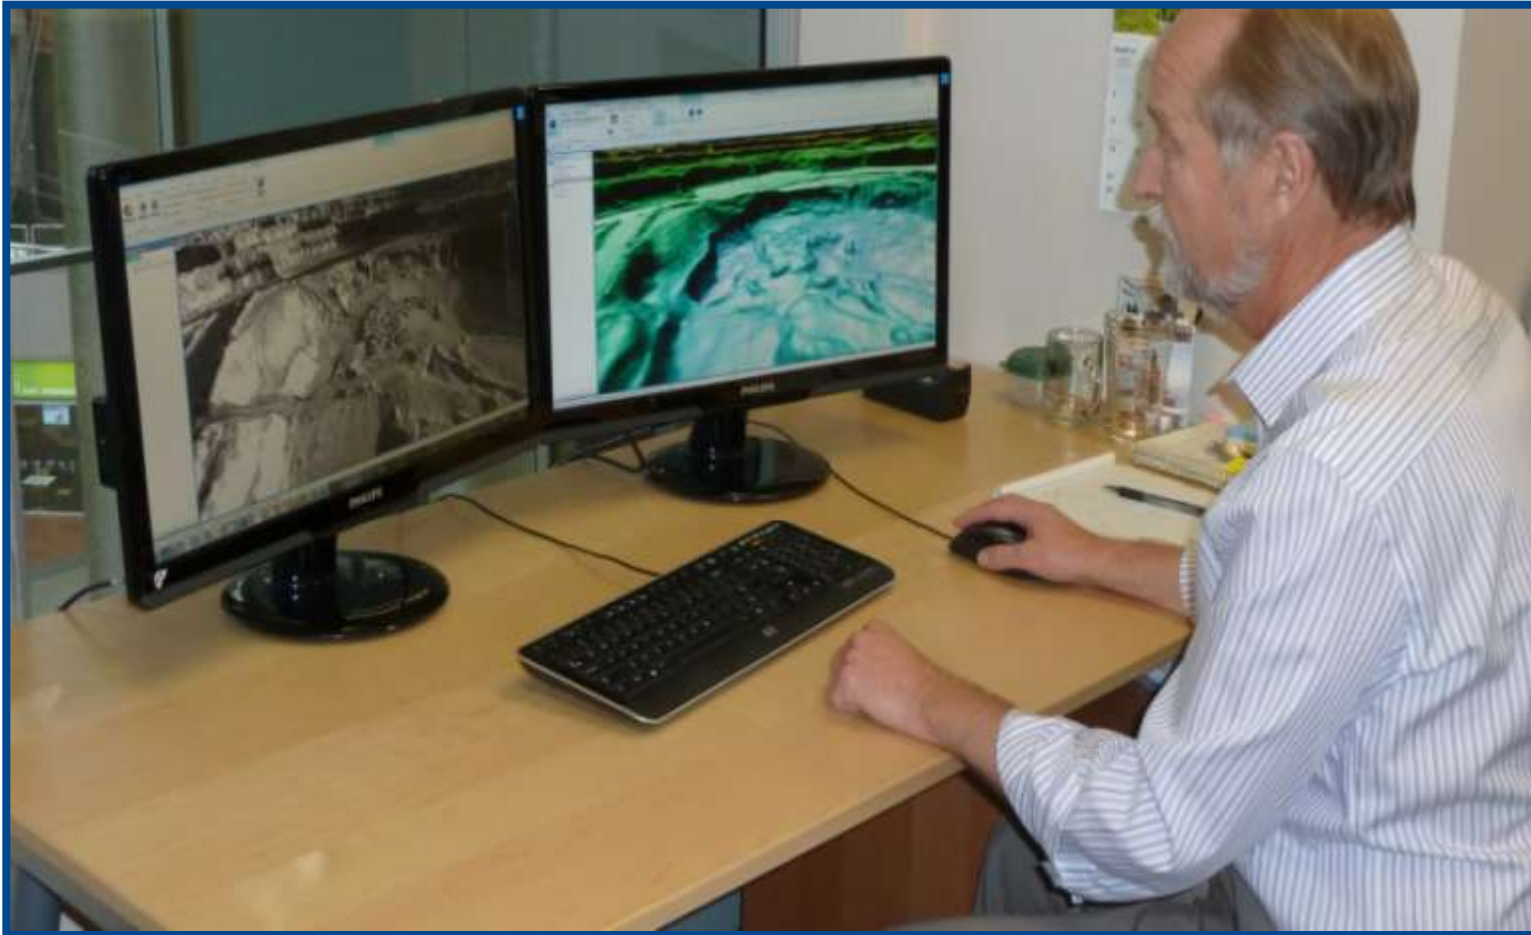
Satellite topographic surface displayed in a 3D seismic workstation.

***PhotoSat 3D stereo satellite
processing and visualization system***

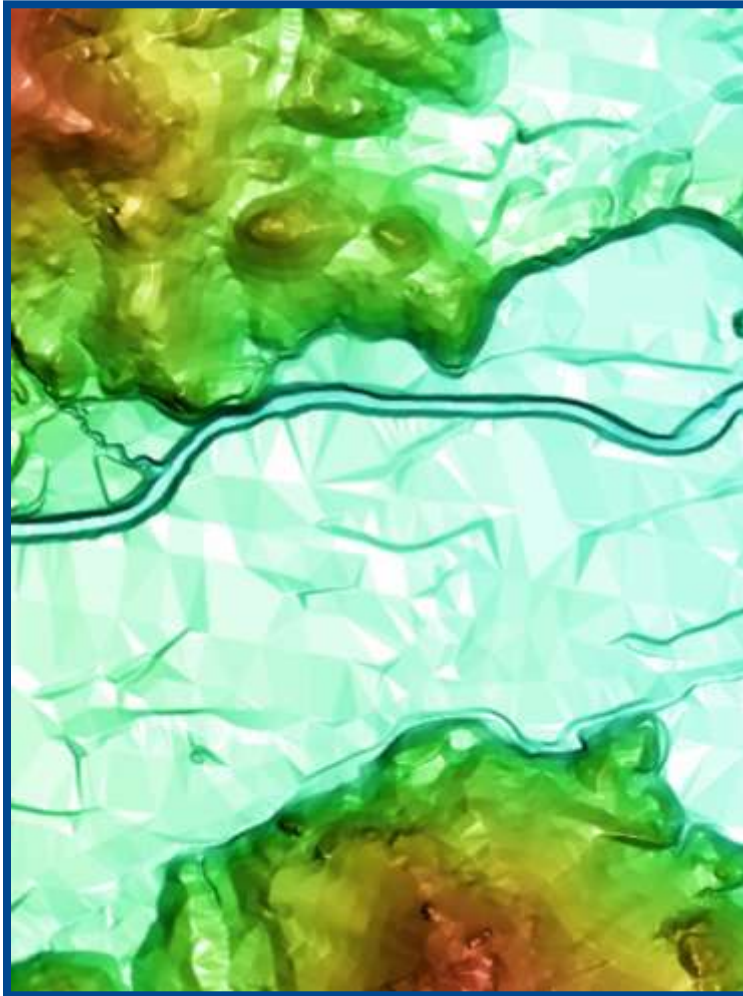
Better topographic detail

**Conventional
Photogrammetric mapping**

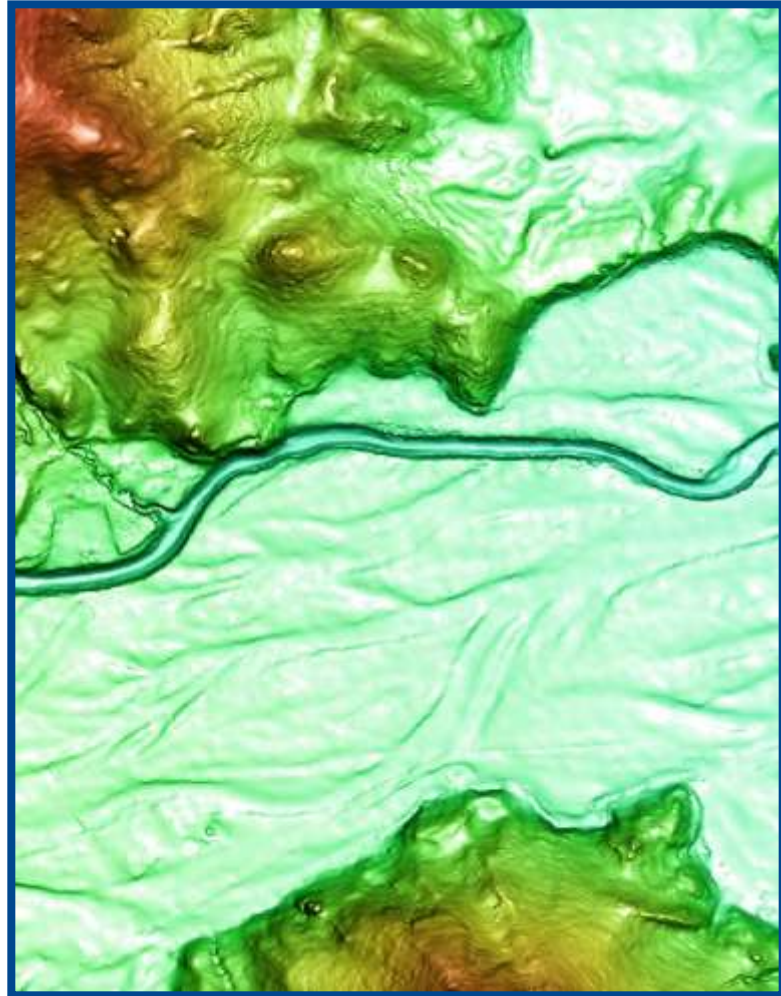
PhotoSat mapping

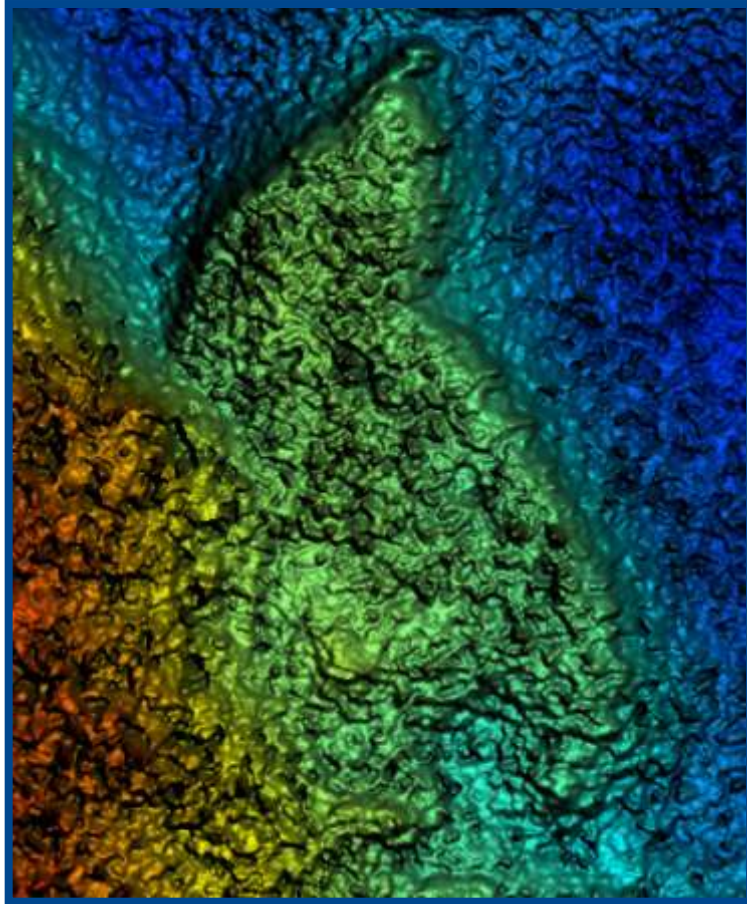
Lower topographic noise

Photogrammetric mapping

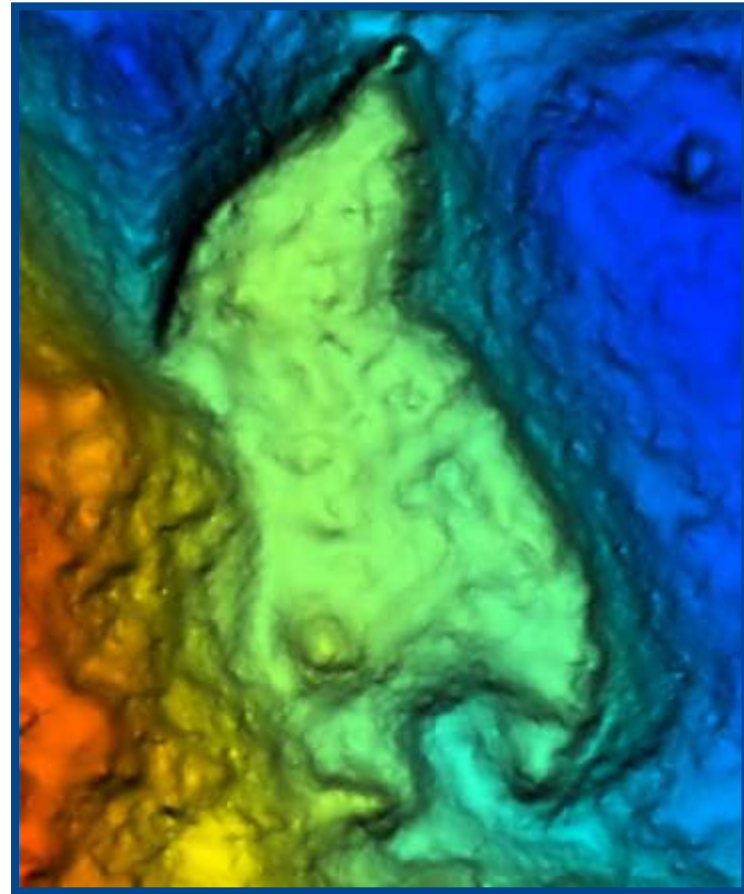
PhotoSat mapping

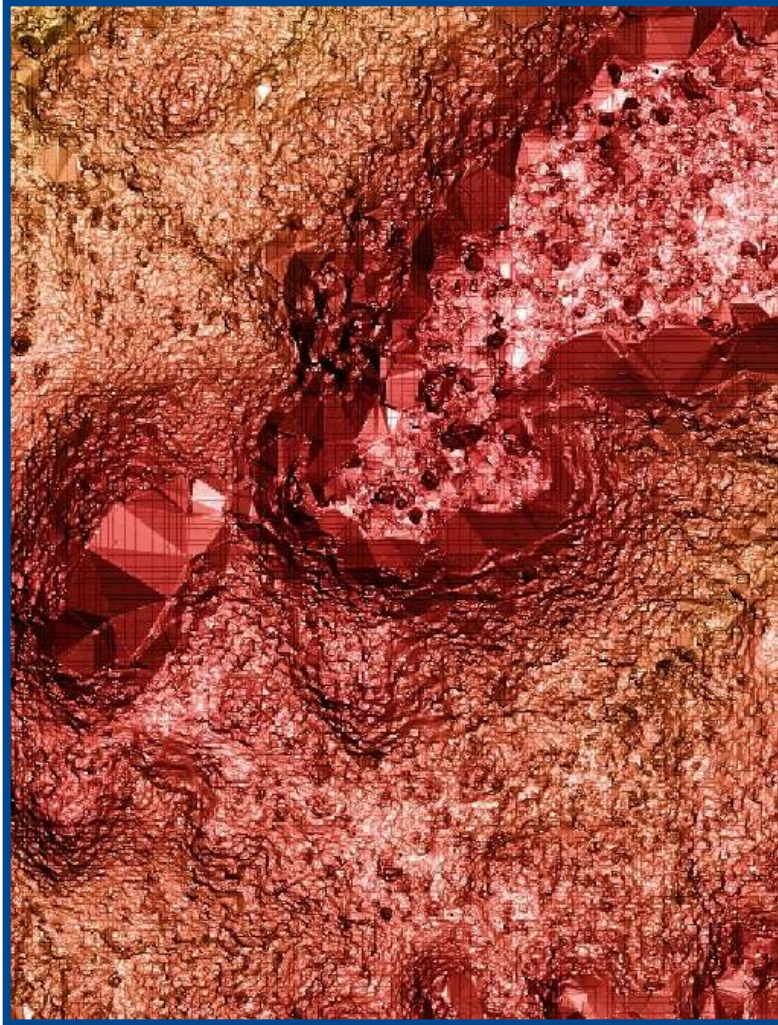
Better resolution of steep slopes

Photogrammetric mapping

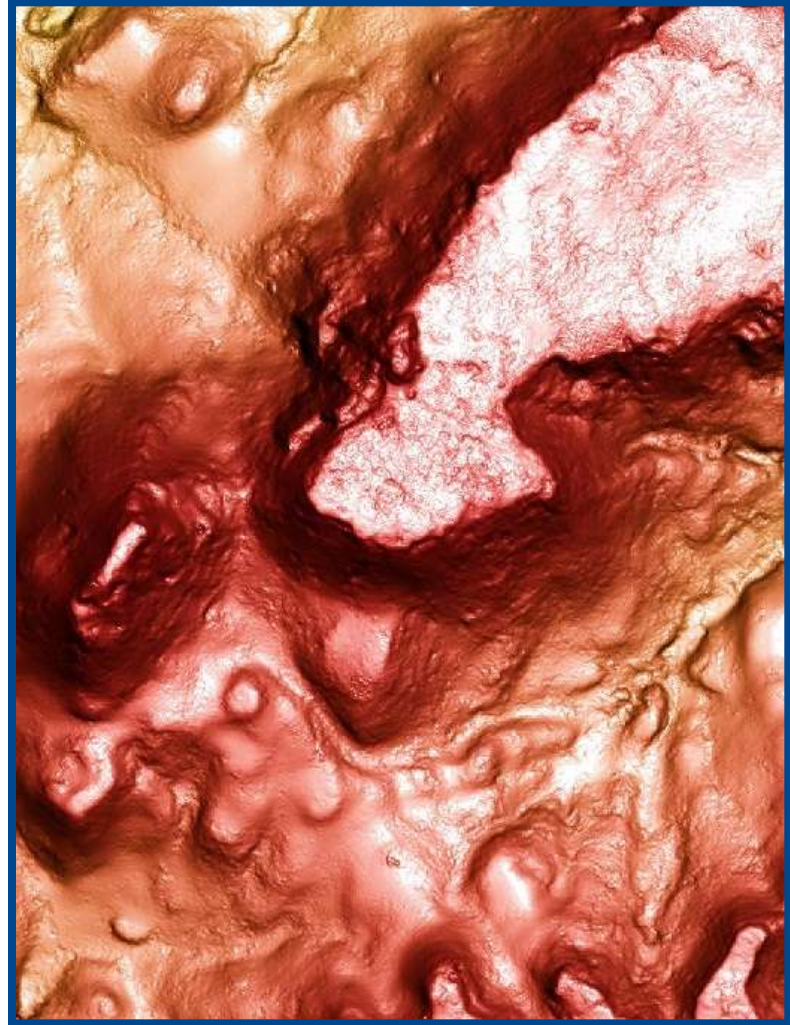
PhotoSat mapping

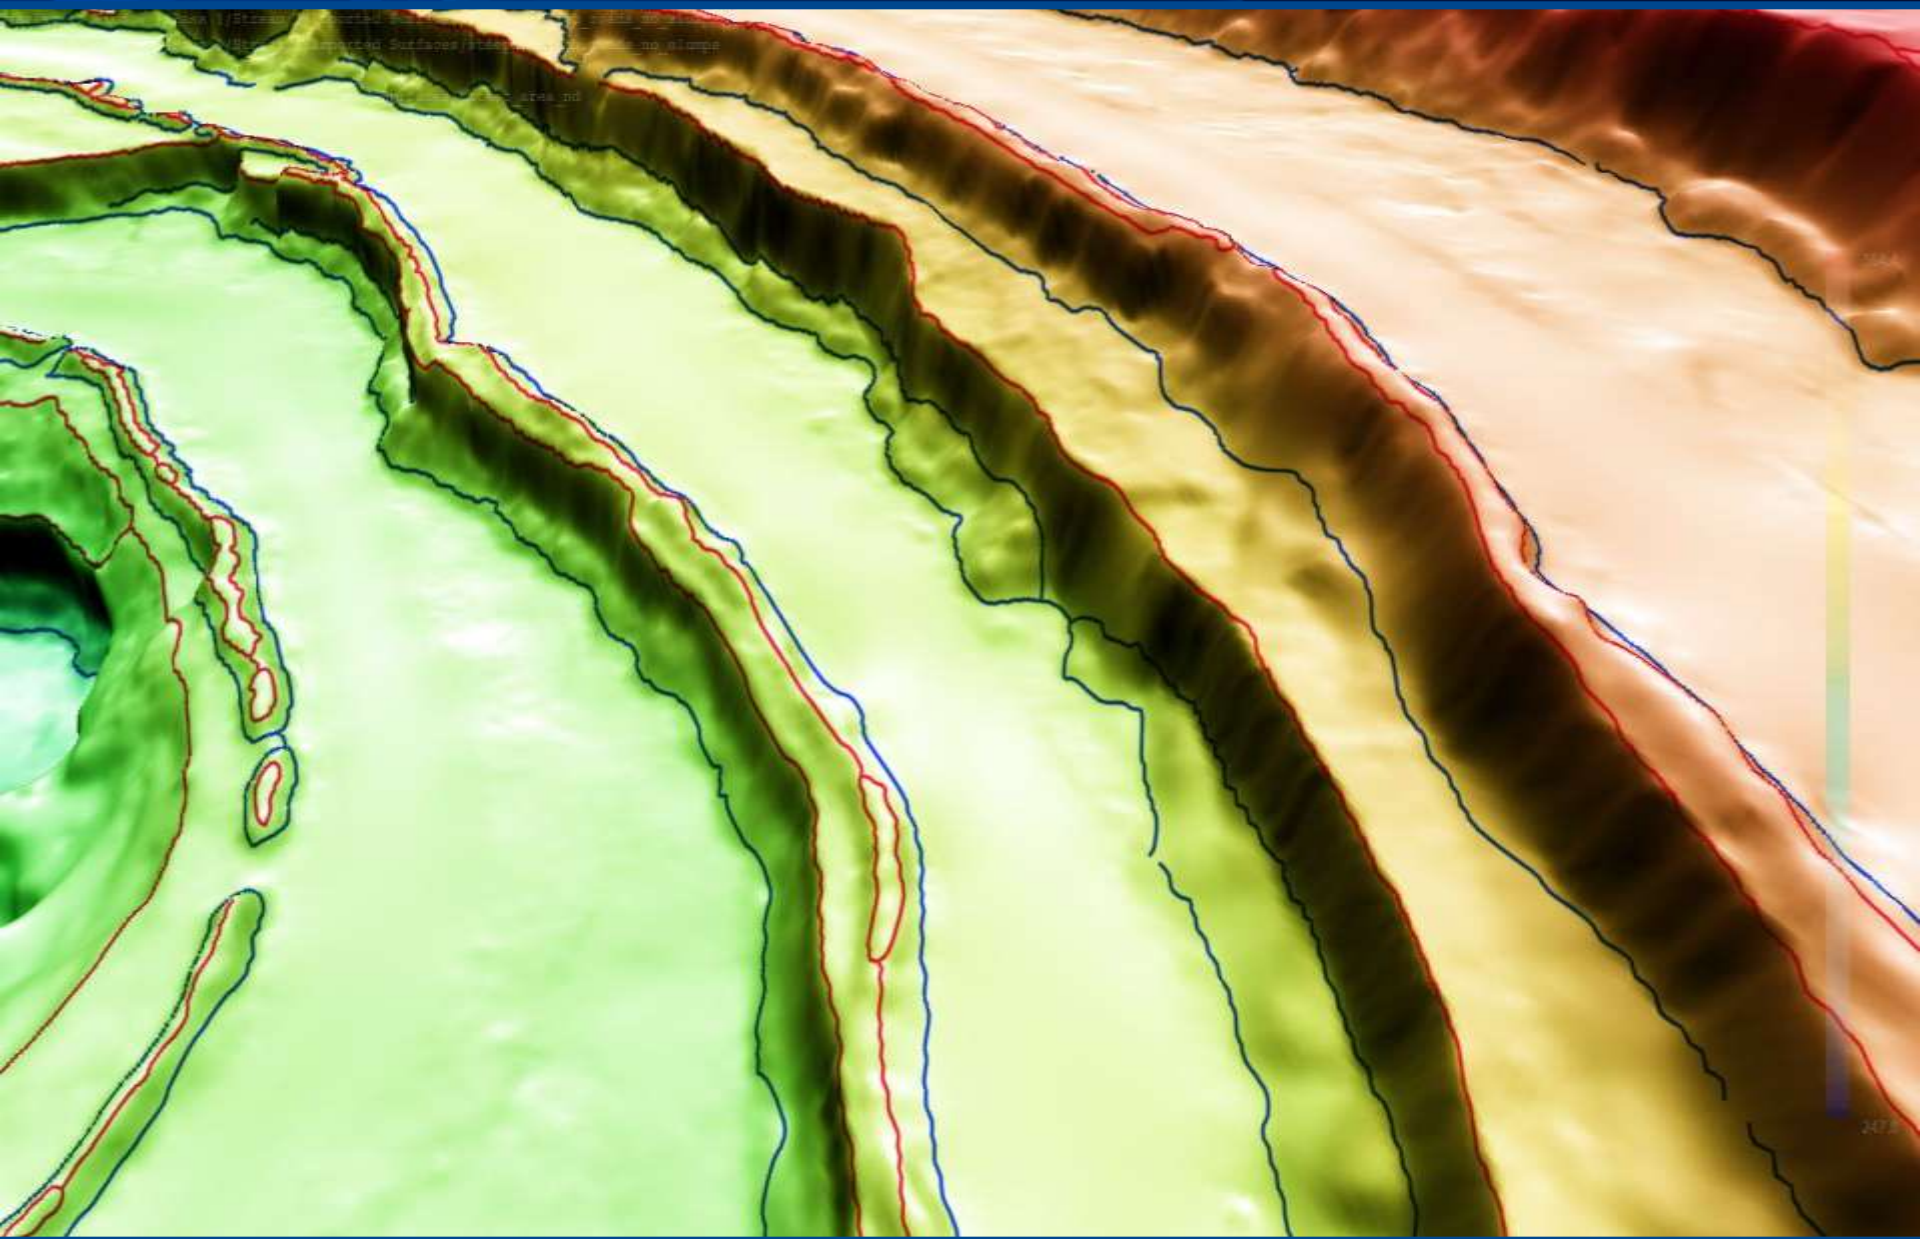
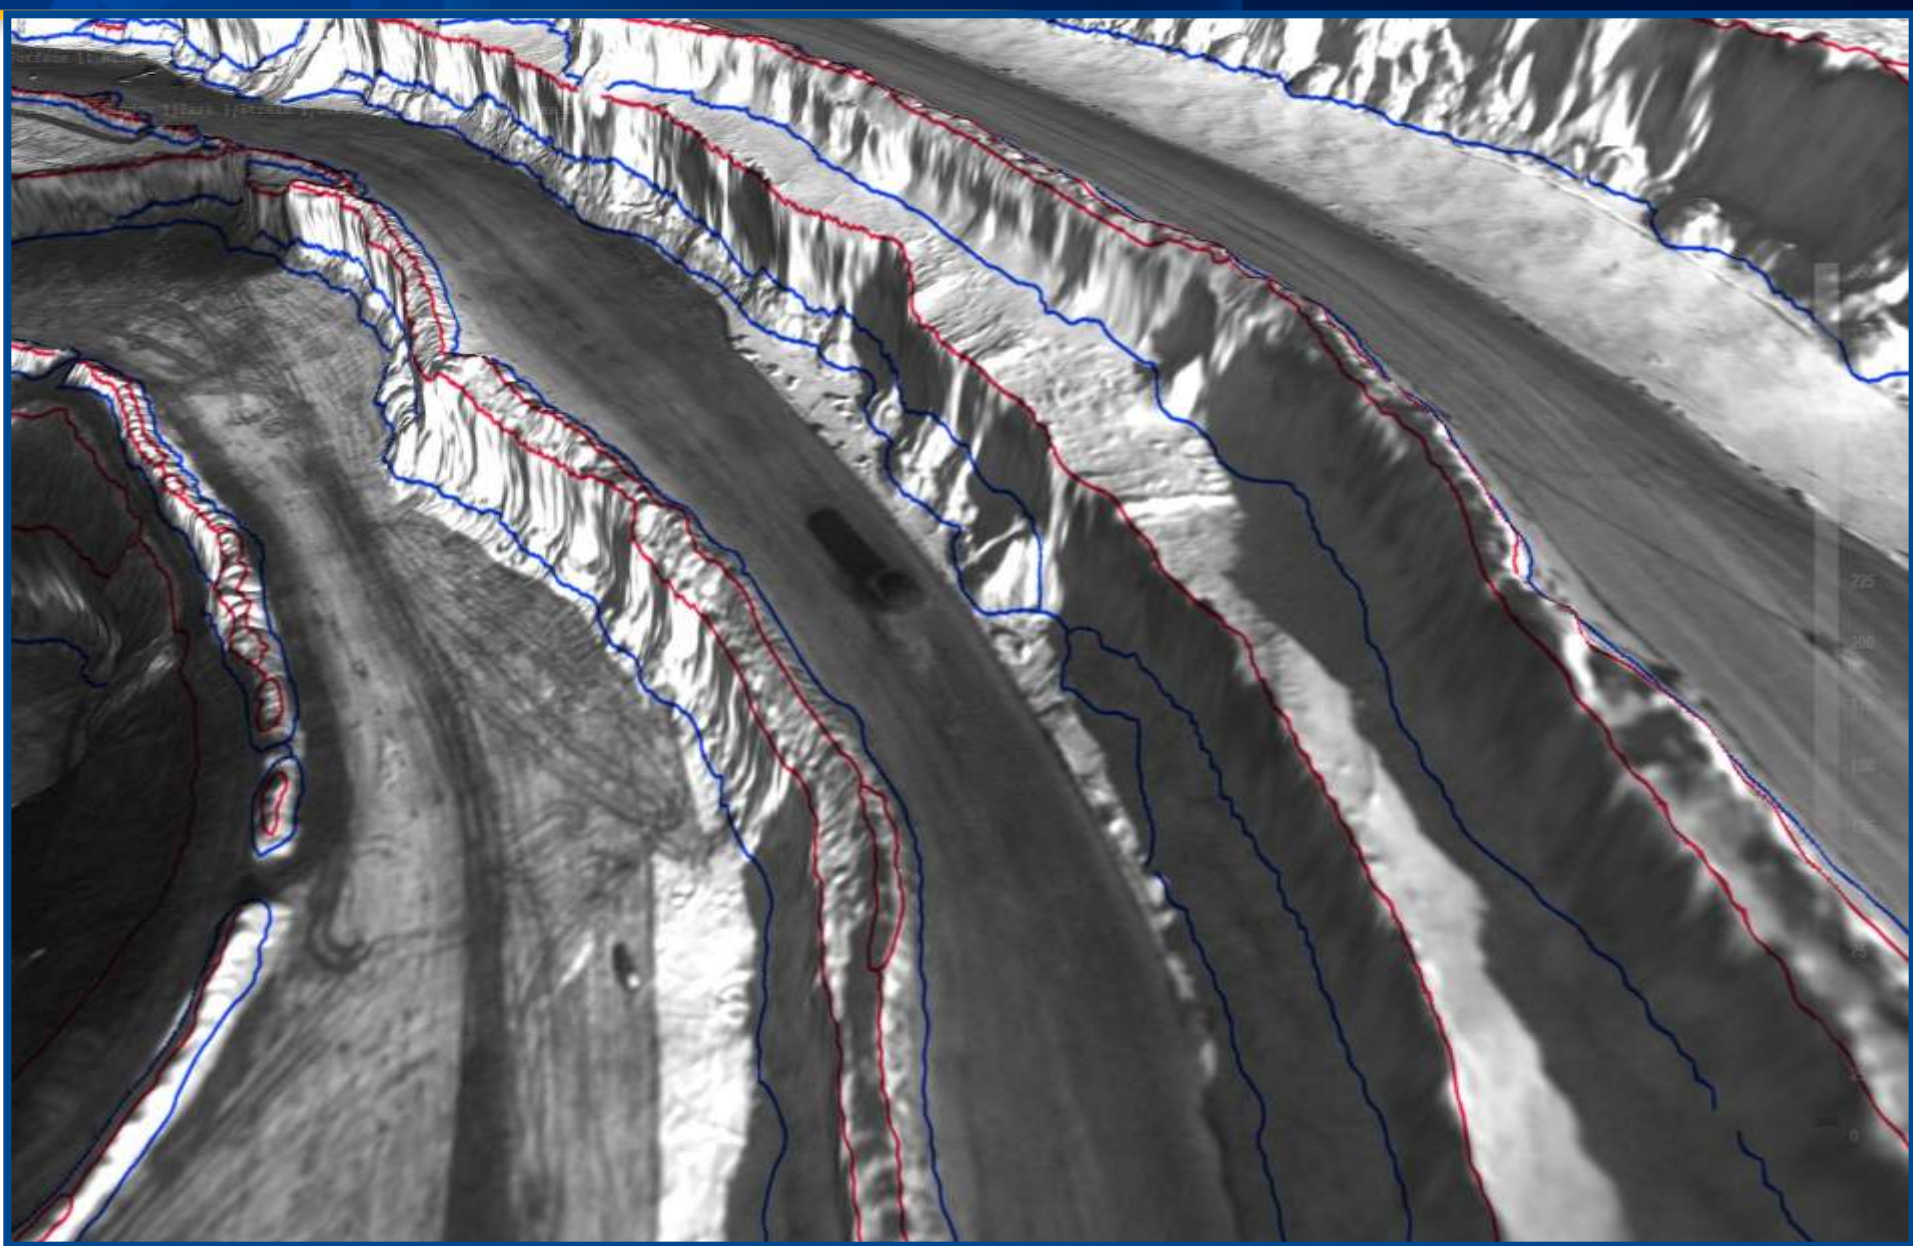
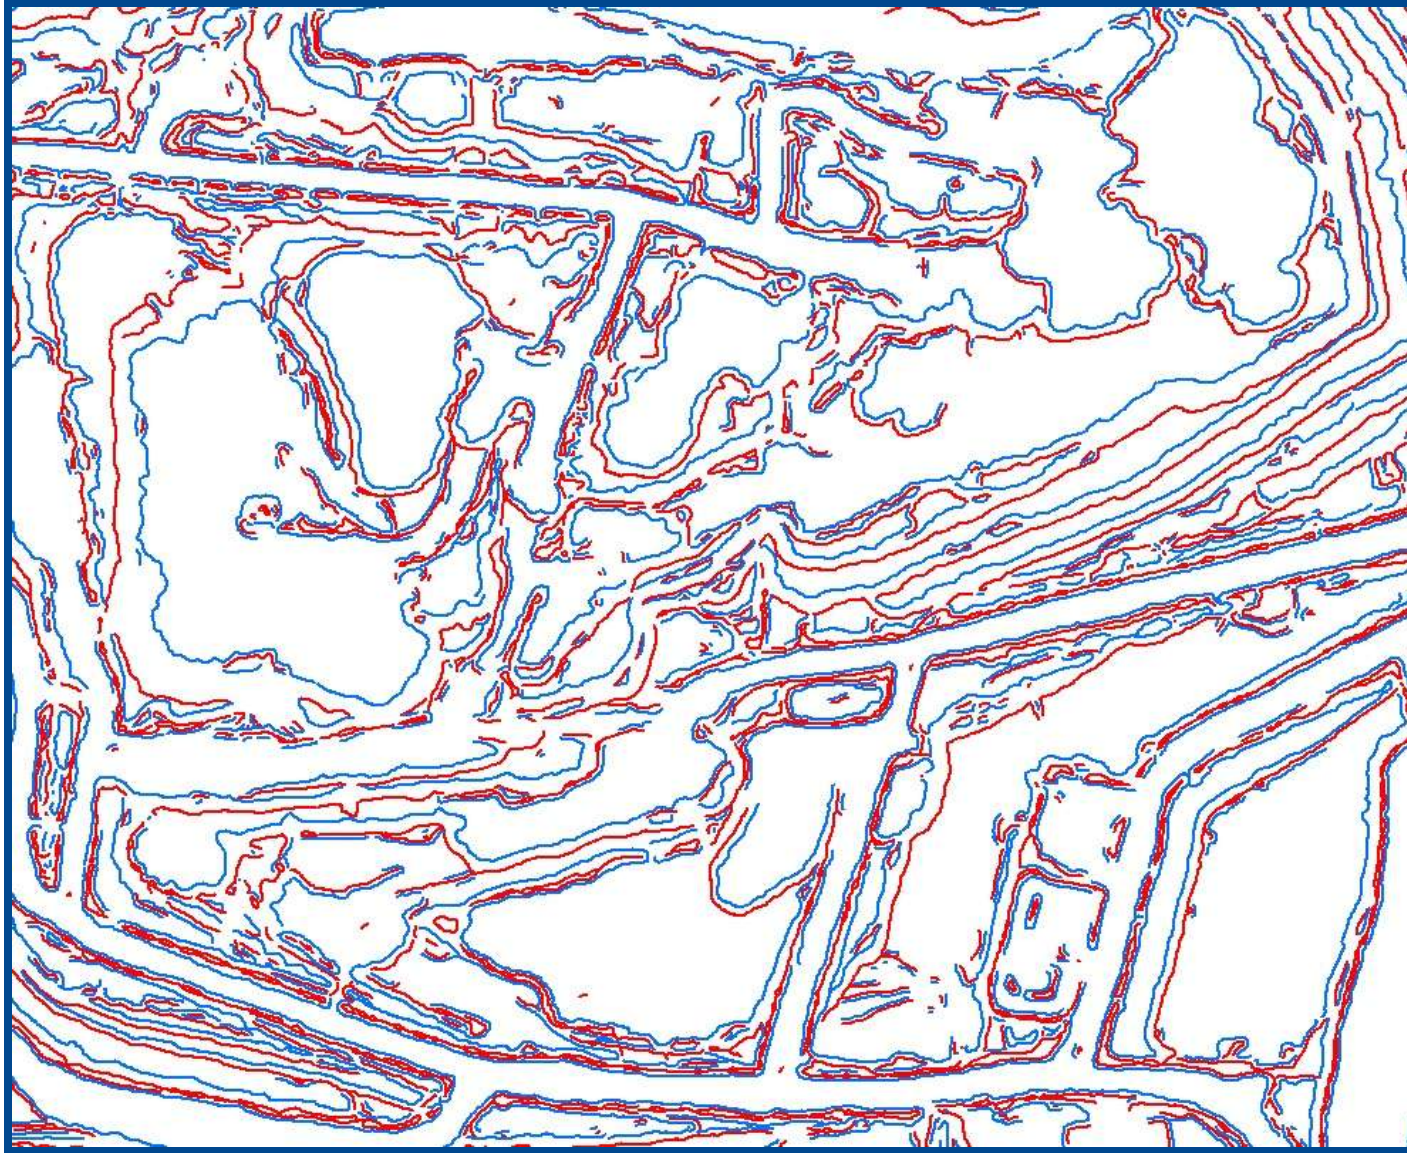
In collaboration with Suncor PhotoSat developed a process for automatically mapping the mine site toes and crests.

Millenium Toes and Crests

Millenium Mine Toes and Crests
