Session ID: GEO-6307
Mapping and Monitoring
for Suncor's Oil Sands Tailings
Reduction Operation process
using GPS surveying and
PhotoSat satellite topography.

Paul Lomond, Suncor Energy Inc.

Jim Turner, PhotoSat

Stereo satellite photos used to map Suncor Tailings

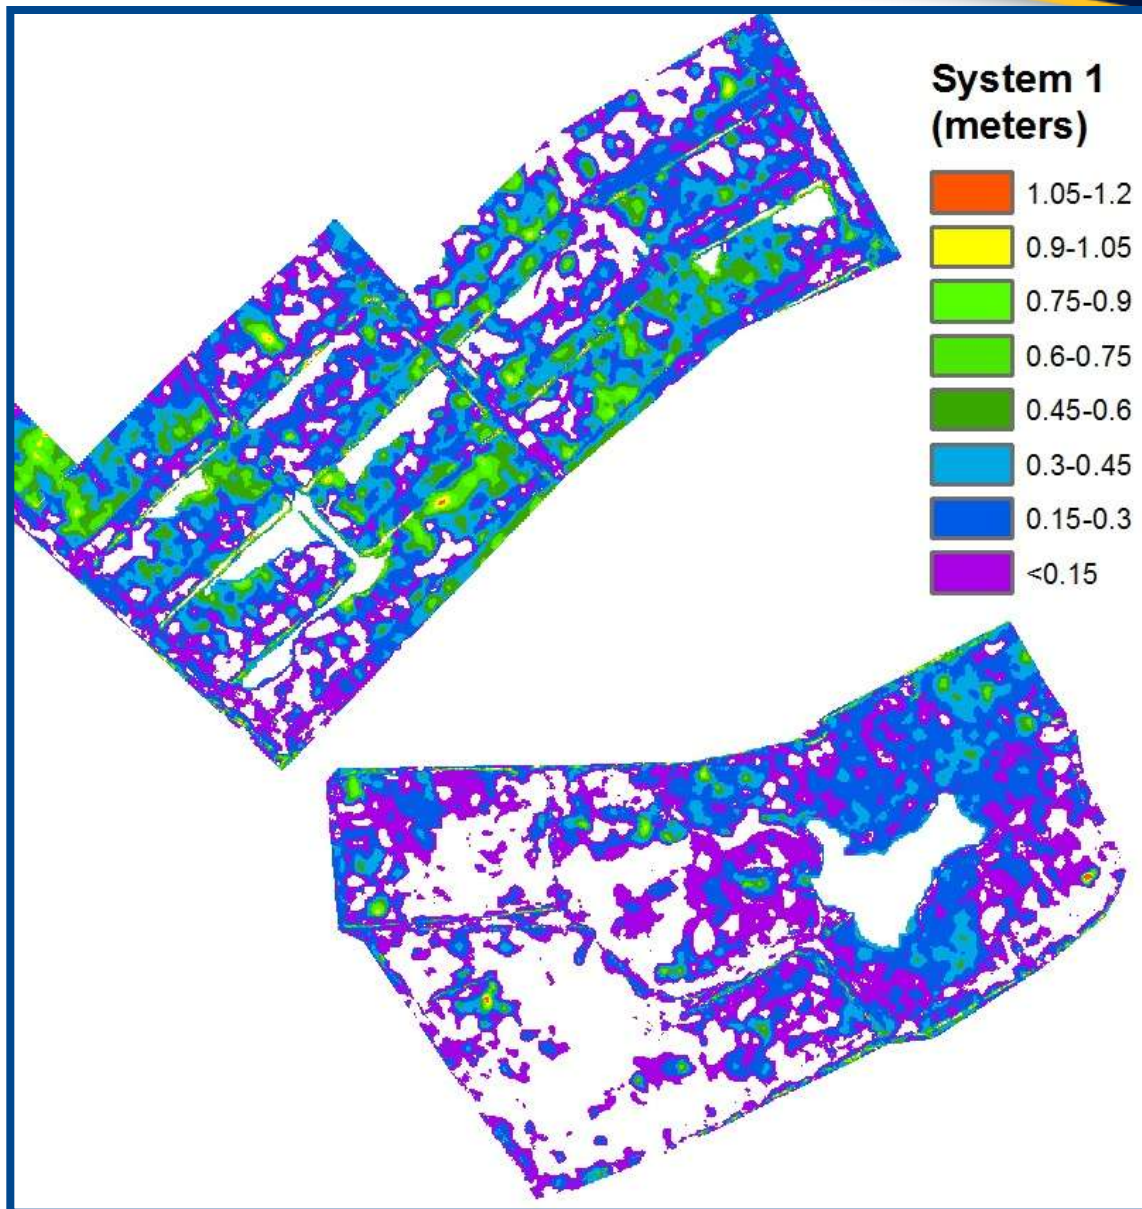
In collaboration with Suncor PhotoSat is developing a process for automatically mapping the thickness of the Mature Fine Tailings dewatering cells between satellite mapping passes in increments of 15cm thickness.

System 1, Isopach June 29 to July 13
